IIW/IIS - DOCUMENT XIII - 1964 - 03

**Comparison of the Improvement in Corrosion Fatigue Strength of  
Weld Repaired Marine Cu 3-grade Bronze Propellers by Ultrasonic  
Impact Treatment (UIT) or Heat Treatment**

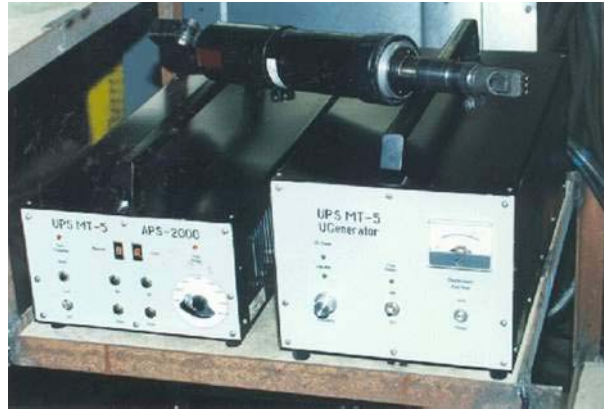
Fig. 1 UIT equipment

UIT equipment (Fig. 1) developed and manufactured at NSTC comprises the following components:

- power supply UPS MT-5 APS-2000,
- ultrasonic generator UPS MT-5 UGenerator,
- ultrasonic impact tool.

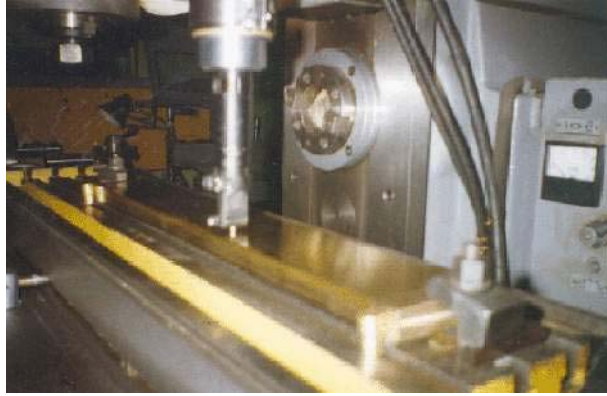
Fig. 9 Mechanized UIT

After final fabrication, all surfaces of specimens of series 3 were treated by mechanized UIT, including both deposited weld area and base metal to relieve residual welding stresses and harden the surface layer of the base metal and deposit (Fig. 9). This UIT technique would be intended to increase the corrosion fatigue strength of the entire propeller blade.

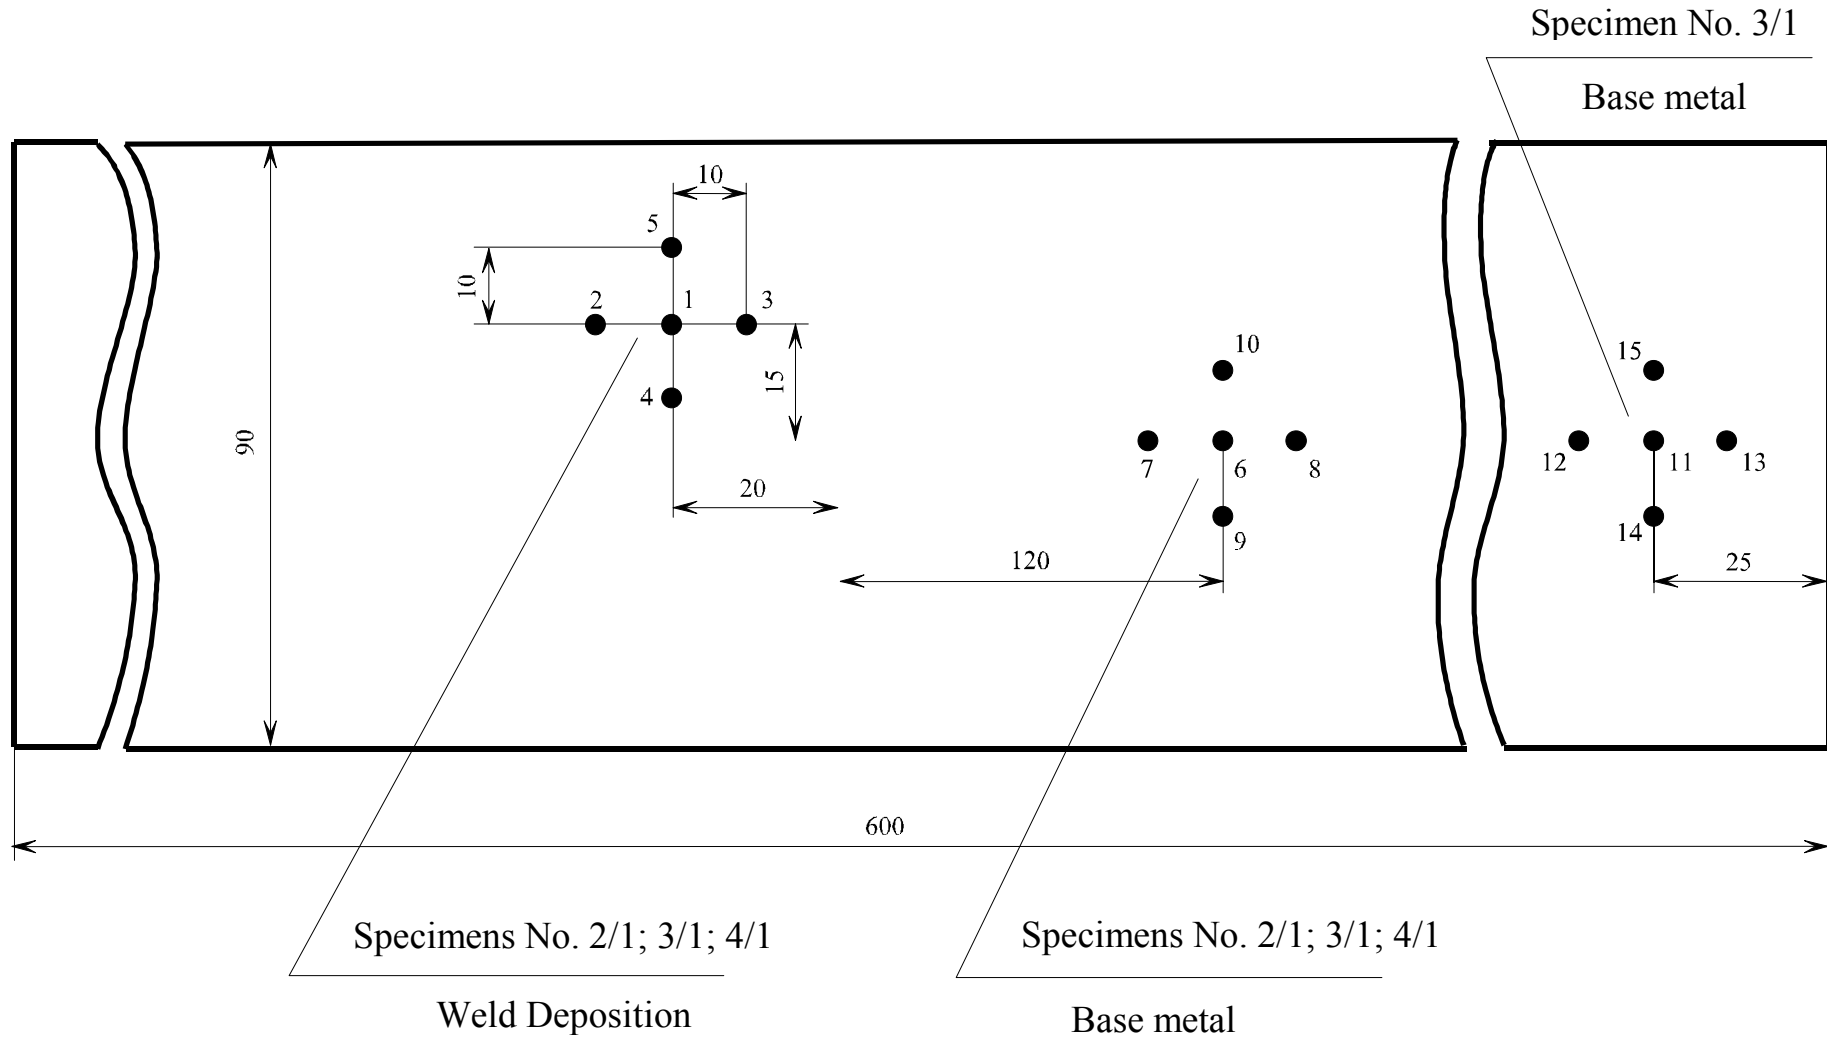
Fig. 10 Diagram of hardness measurement on bronze specimens

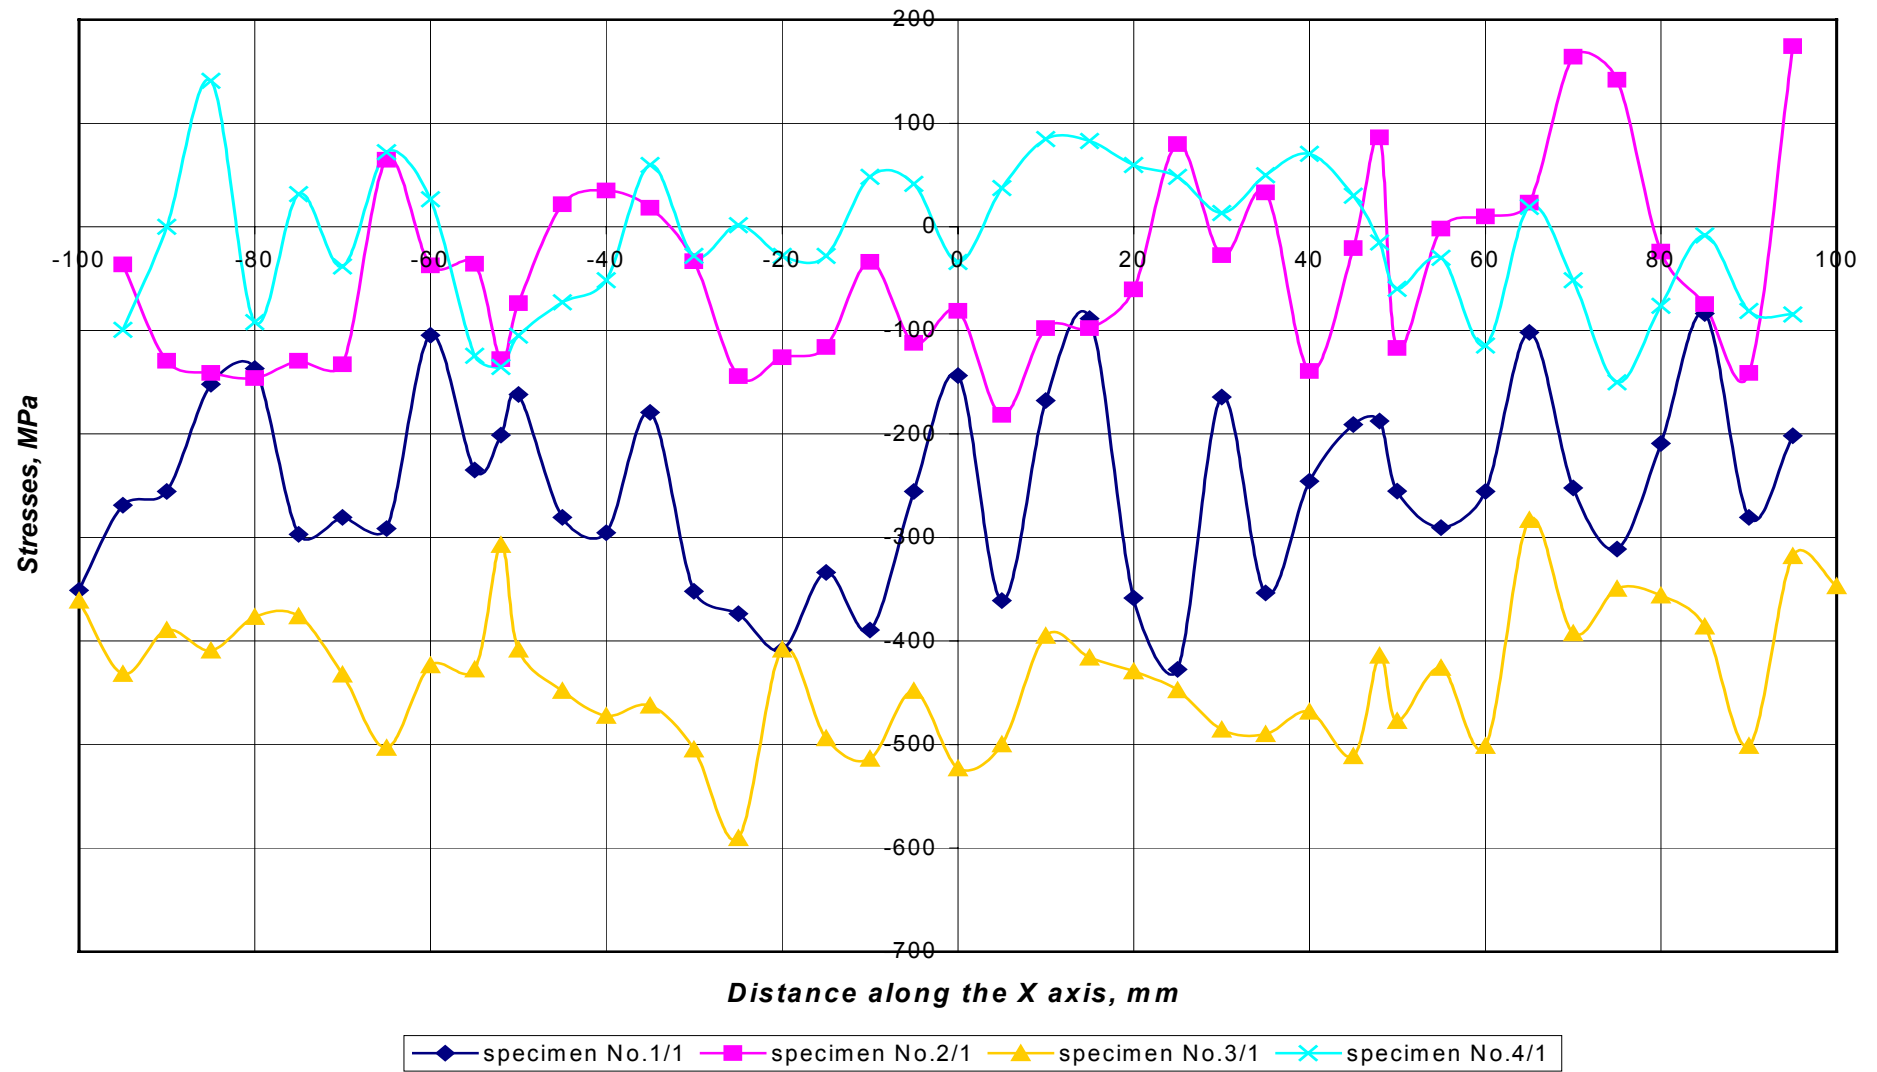
Fig. 12 Diagram of residual stress distribution along the X axis in longitudinal direction

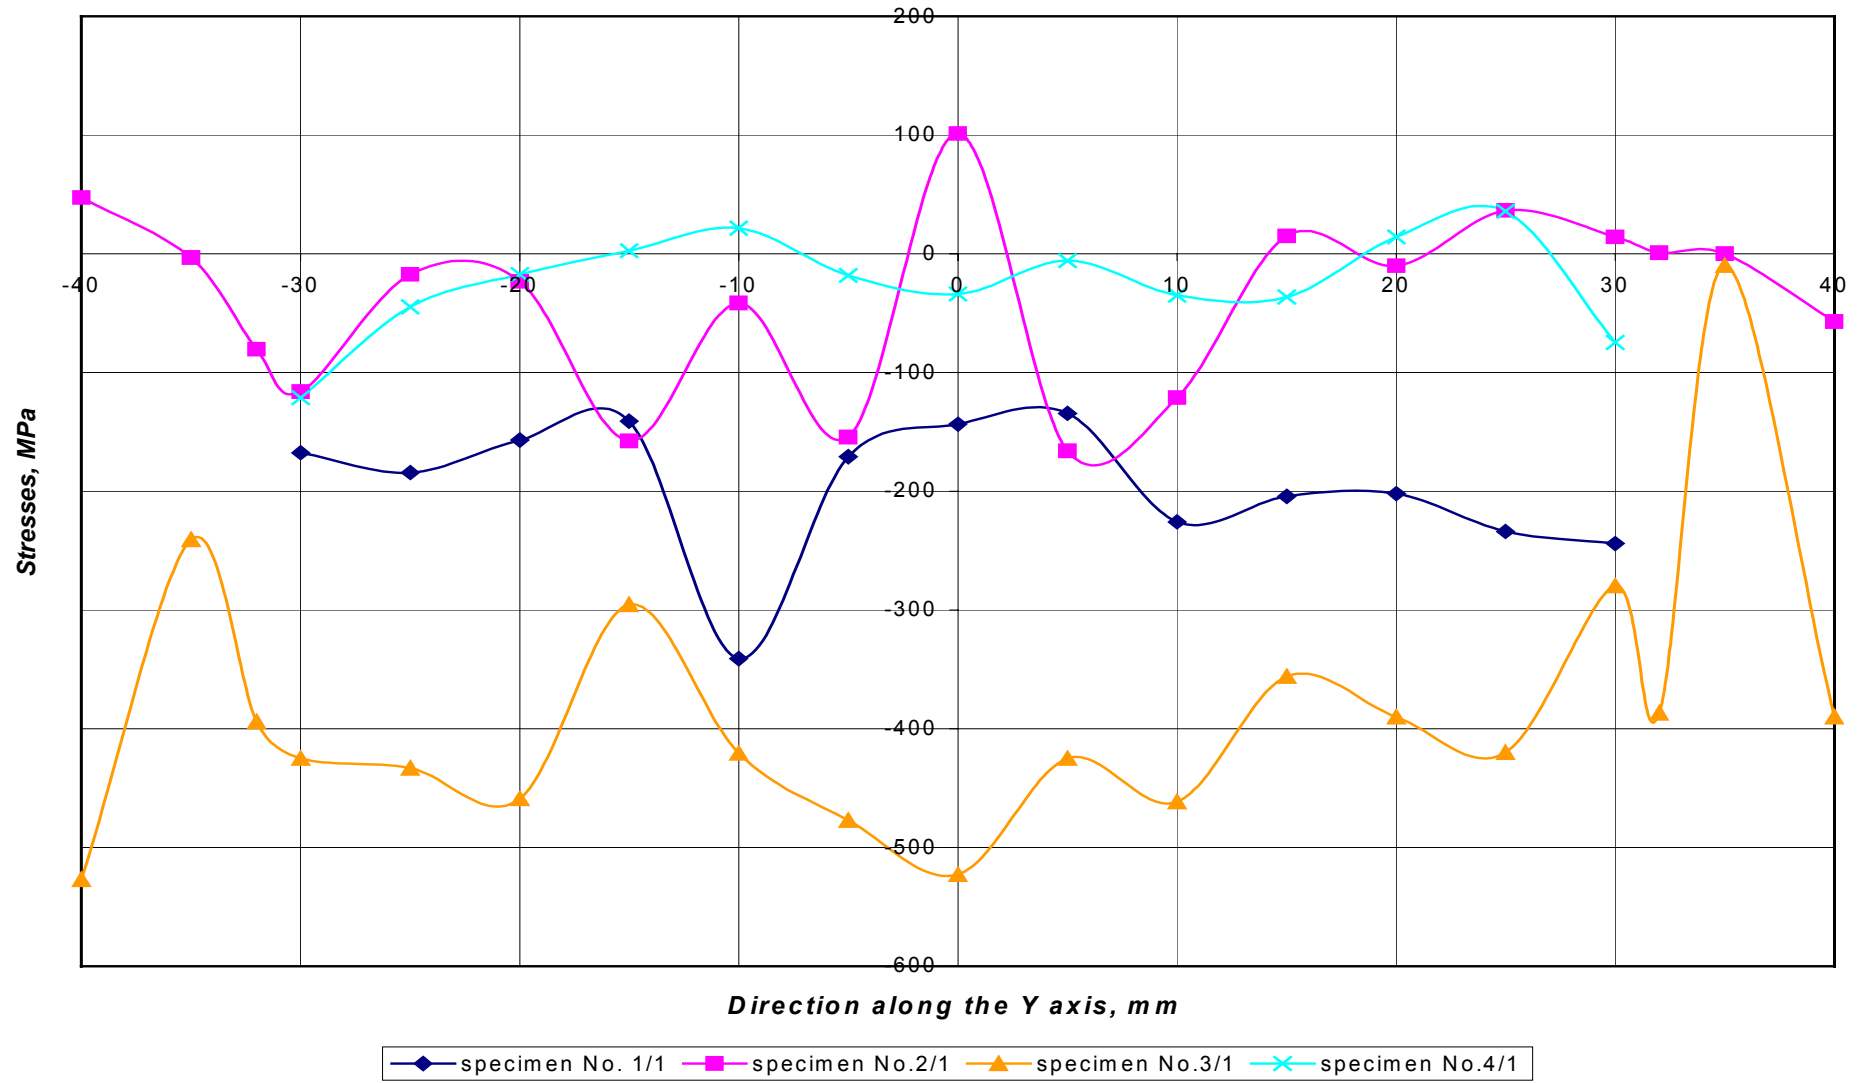
Fig. 14 Diagram of residual stress distribution along the Y axis in longitudinal direction

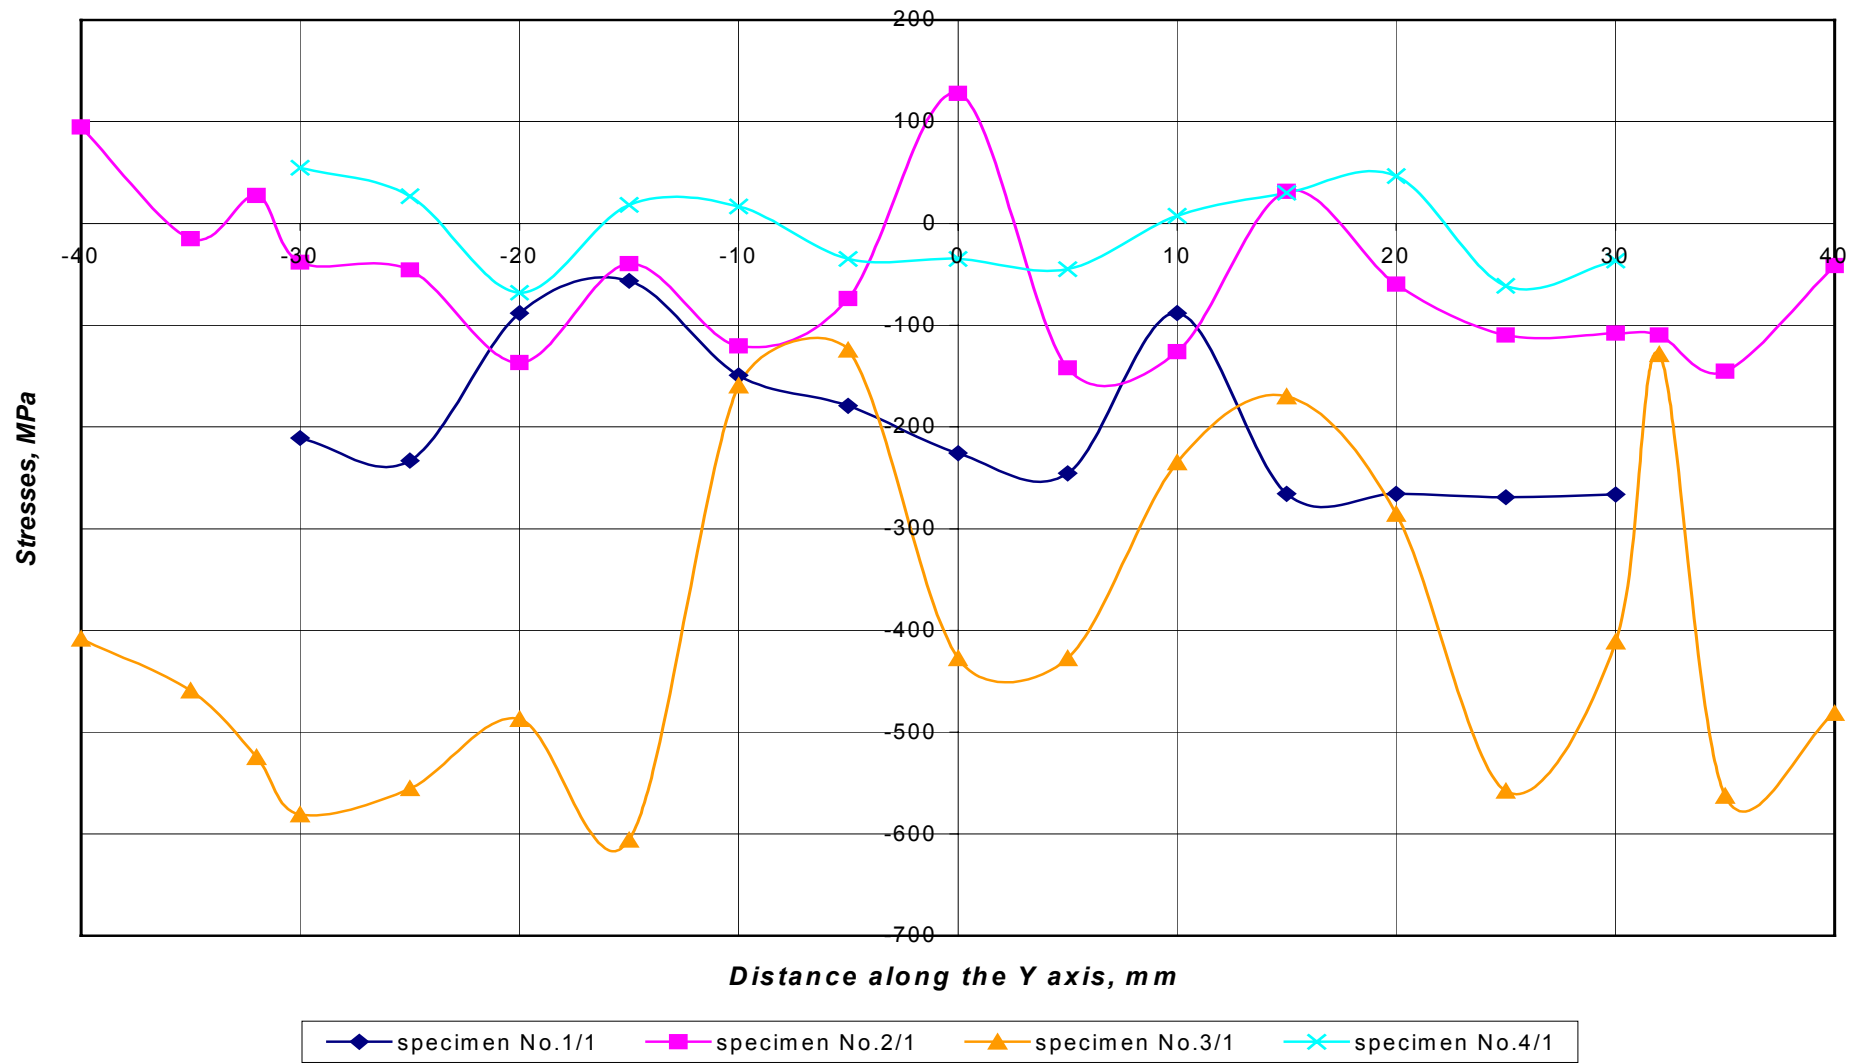
Fig. 15 Diagram of residual stress distribution along the Y axis in transverse direction

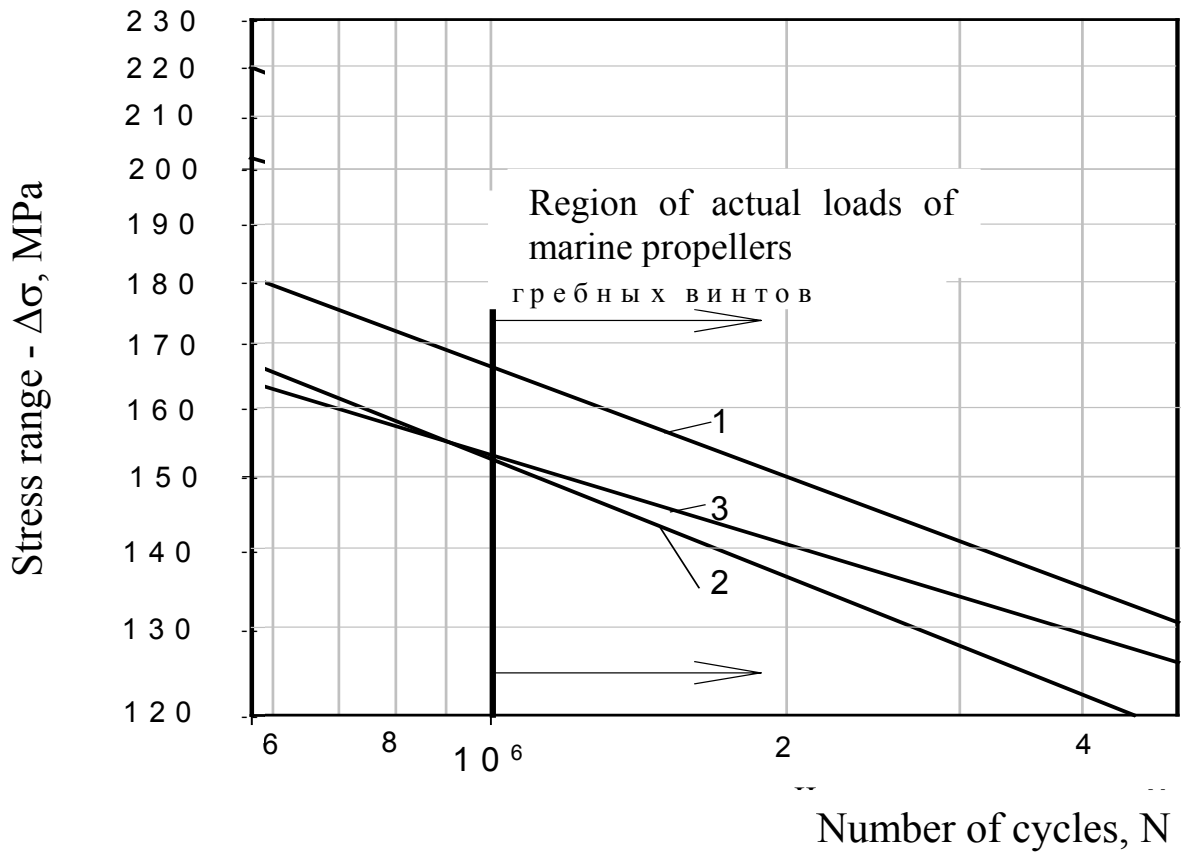
Fig. 16 Fatigue curves for bronze specimens (axial loading  $r = 0,5$ ) in synthetic salt water: 1 – base metal; 2 – deposition plus heat treatment; 3 – deposition plus UIT

Based on a comparison of fatigue test results, the corrosion fatigue resistance of UIT treated bronze specimens containing weld deposits is about 86% of the corrosion fatigue resistance of the base-metal specimens in the low-cycle regime, and about 94% in the high-cycle regime. By comparison, the corrosion fatigue resistance of heat treated specimens in the same regimes is respectively 93% and 90% of the base metal. This suggests that in synthetic salt water the benefit of UIT of deposited welds increases with reduction in variable amplitude loading level, and conversely in the case of heat treatment. This is due to non-parallelism of fatigue curves for the base metal and improved specimens with deposits. The fatigue curve slope for UIT treated specimens is lower than that for the base metal. In contrast, the fatigue curve slope for heat treated specimens is higher than that for the base metal.

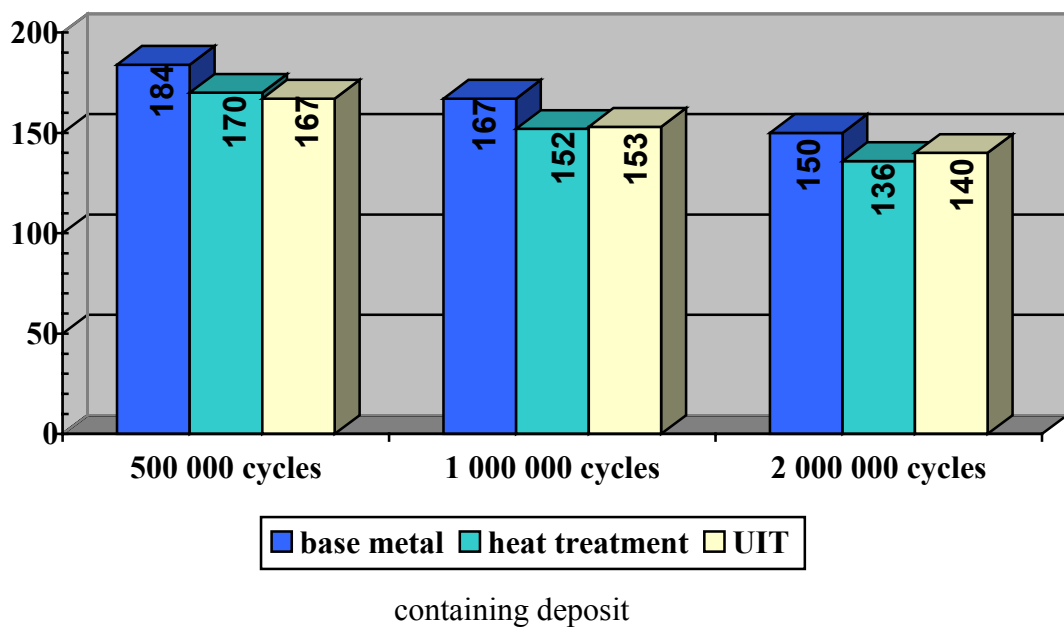
Fig. 17 Effect of heat treatment and UIT on corrosion cyclic life of plate in bronze BrA9Zn4N4

containing deposit

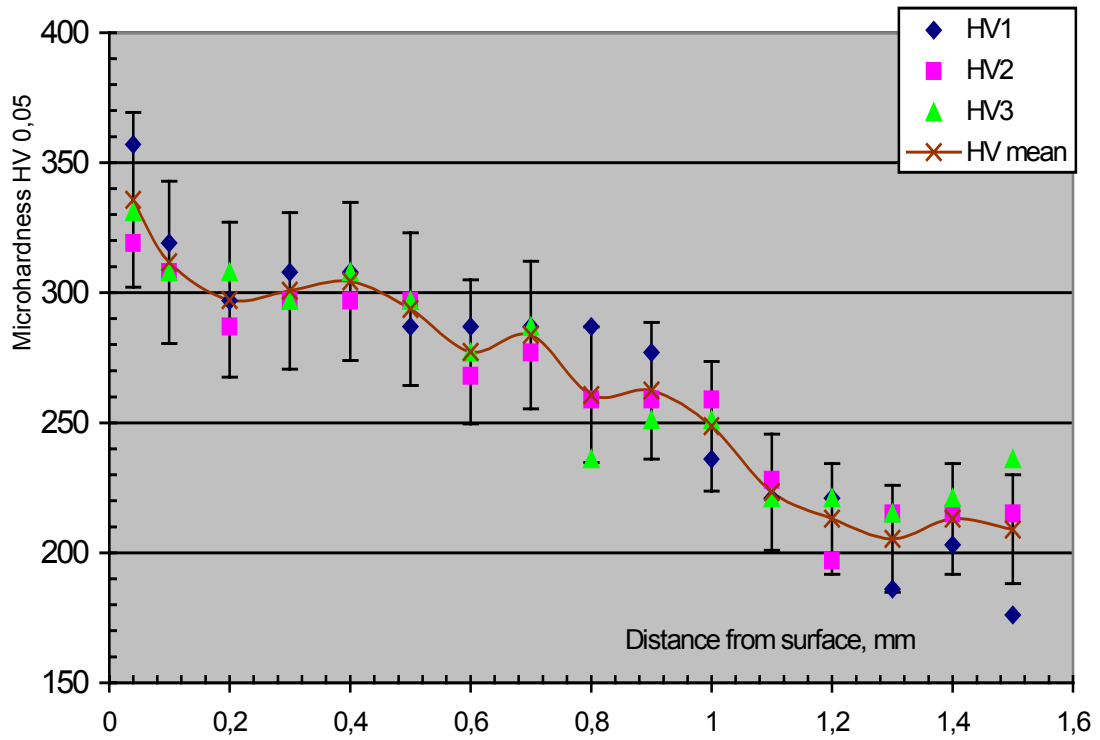
Fig. 26 Specimen No. 3 – deposited metal treated by manual UIT followed by finish with Durex disk

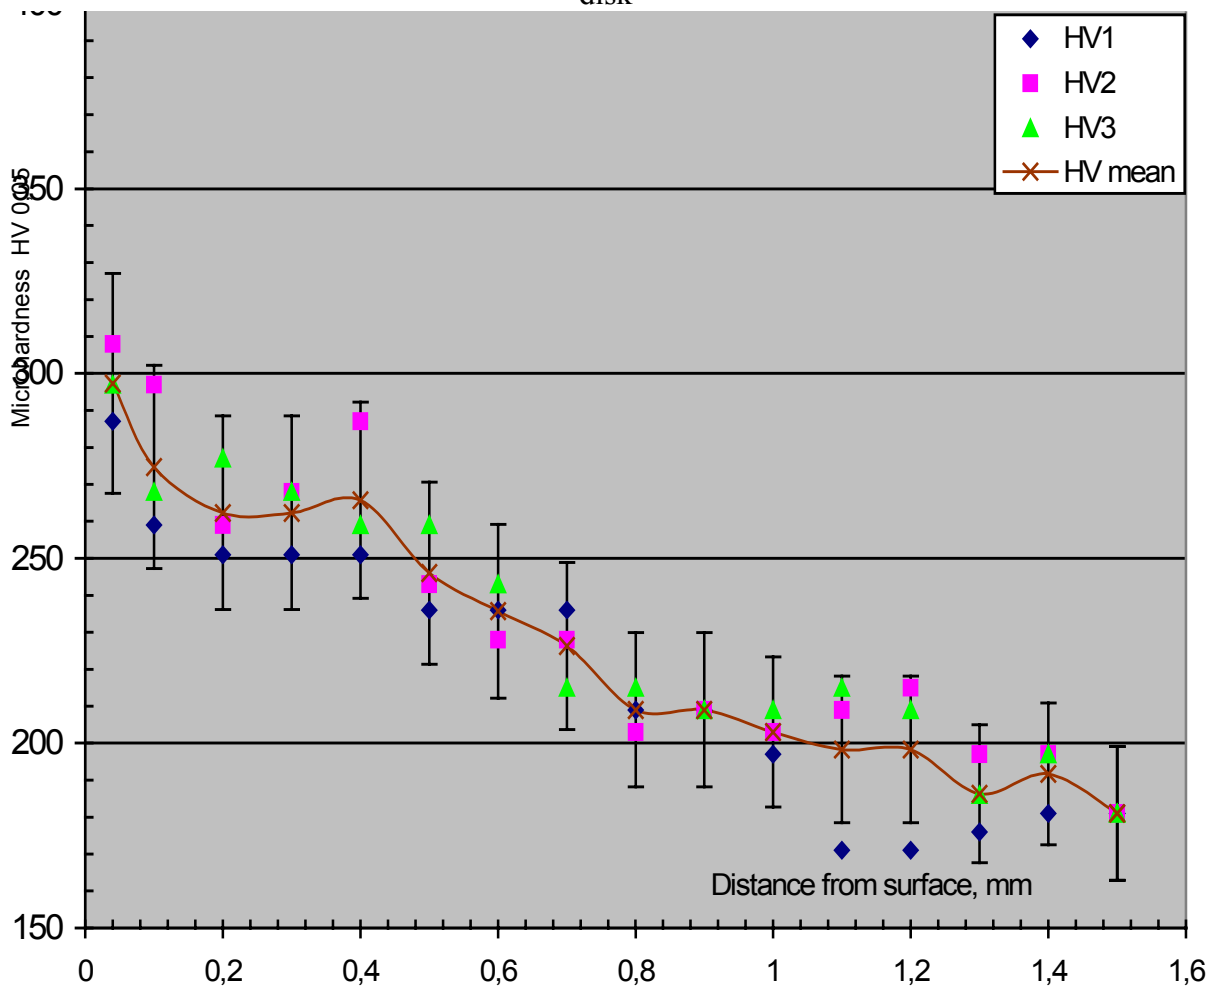
Fig. 27 Specimen No. 4 – base metal treated by manual UIT followed by finish with Durex disk

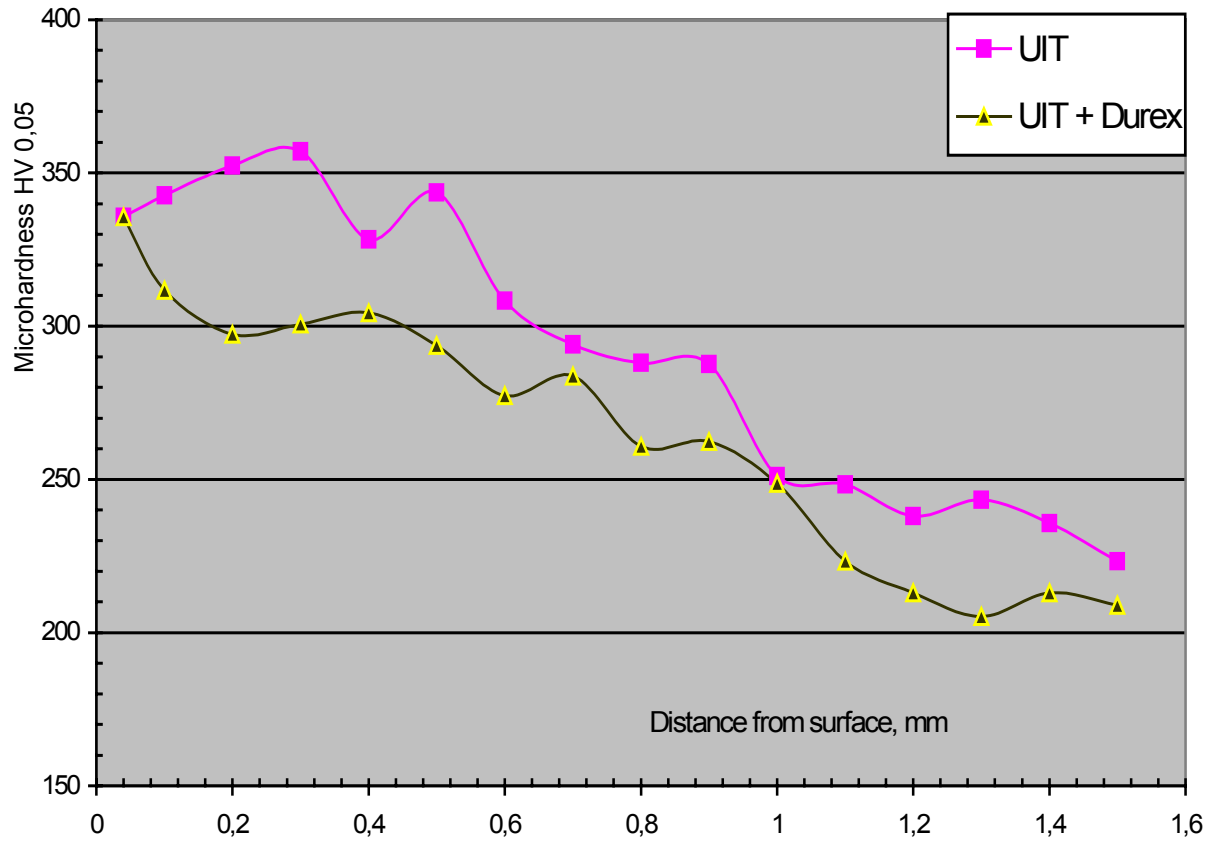
Fig. 30 Microhardness (HV 0,05 mean) of deposited metal after various treatments
